ช่วงล่าง	รายละเอียด	รุ่น	ชุด / คัน	ประกอบด้วย	หมายเหตุ	ราคา / ชุด
Everest MK2 U375 / UA II 2018-2022 Ranger T6 P375 / PX III 2WD 2018-2022 Ranger T6 P375 / PX III 4WD 2018-2022					   	
หน้า	บุชรองคอยล์สปริงบน	SPF5302K	1	2 Bushs	Standard replacement	T.B.A

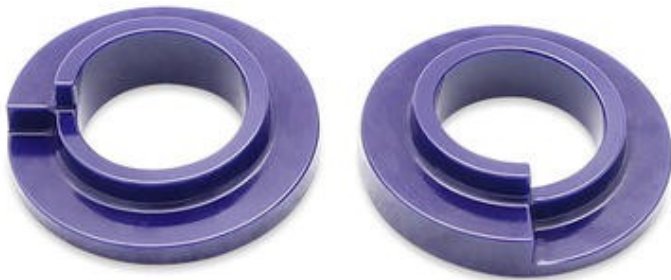
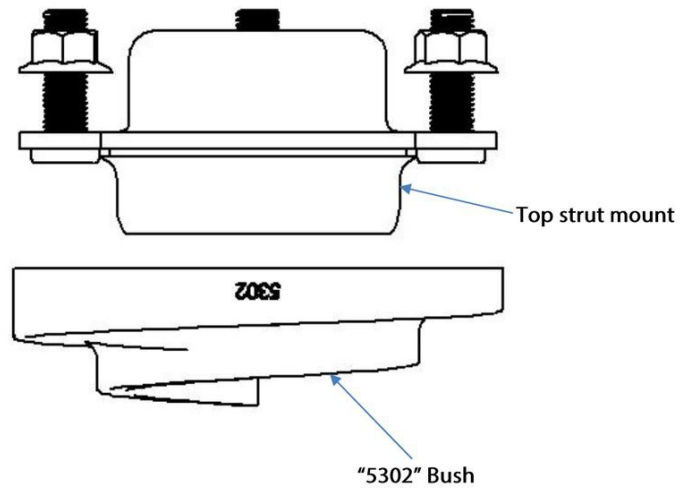
Note: Polyurethane spring seat upper bushings must be fitted to both sides of the vehicle.

1. Support the vehicle on jack stand/hoist and remove the front wheels.
2. Remove the front upper arm outer nut (ball joint side) from the steering knuckle.
3. Remove the front strut assembly from the vehicle.
4. Note the orientation of the top strut mount.
5. With the aid of a spring compressor disassemble the strut and separate the top strut mount assembly.
6. Clean up contact areas and replace the spring seat upper bush.
7. Reassemble the top mount assembly in reverse order, ensure it is orientated as per original.
8. Refit the completed front strut assembly into the vehicle.
9. Tighten all fasteners to manufacturer's torque setting and carry out a wheel alignment.
